READY SCOUT, LLC

East Caroga Lake

Date: Thursday, July 10, 2025

Activity: Lake survey

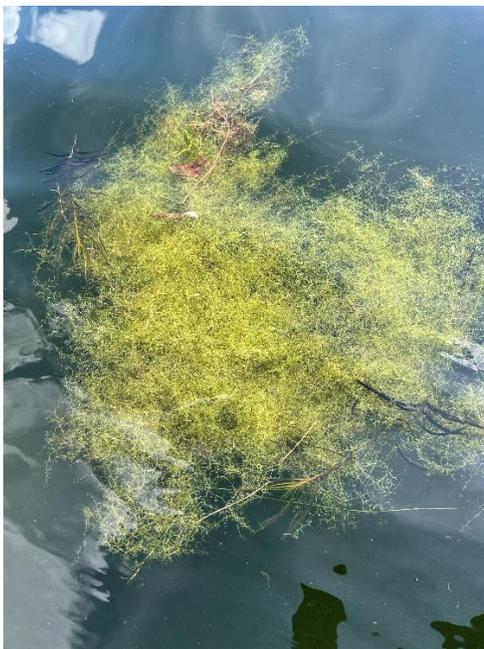
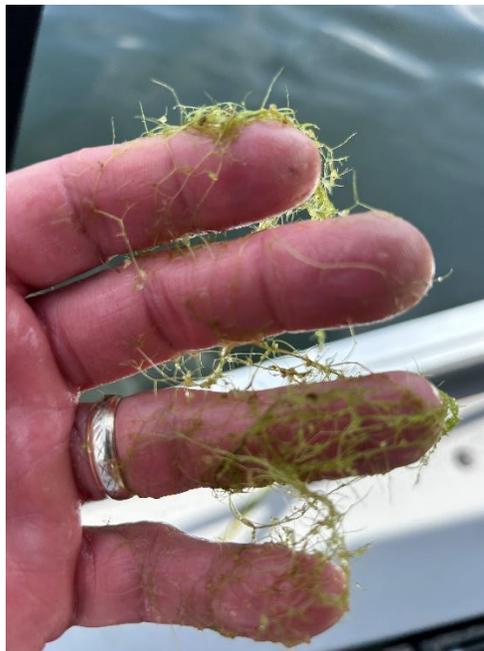
One notable plant observed was Lesser Bladderwort. This appeared in small floating colonies along the middle-south shoreline and could easily be confused with algae growth. Bladderworts take their nutrients from the water column and are free floating, so these small colonies may drift with wind and water movement. See photos below.
