# READY SCOUT, LLC

**West Caroga Lake**

**Date:** Thursday, July 10, 2025

**Activity:** Lake survey

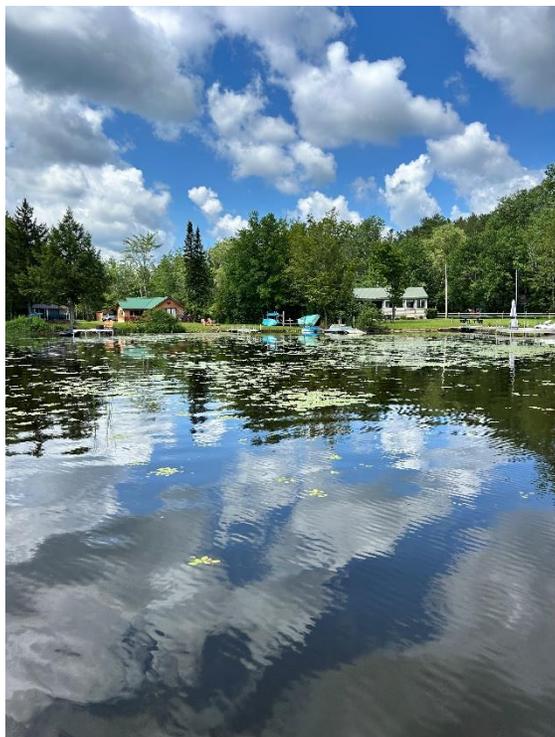
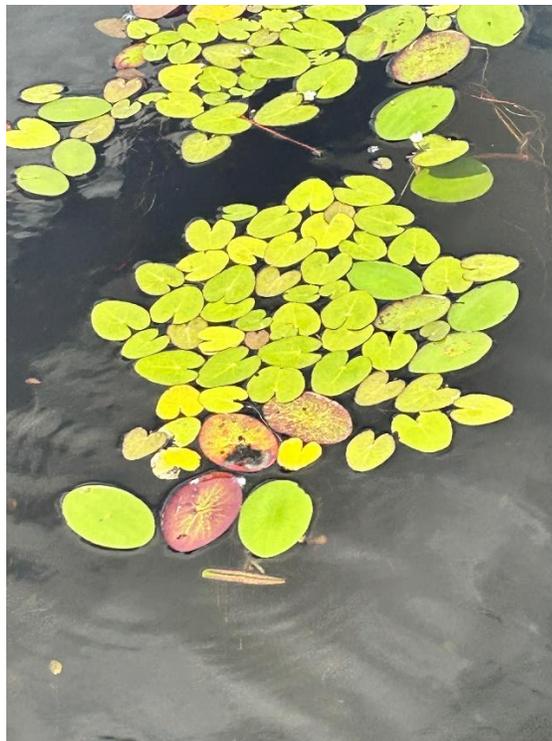
While Watershield (a football shaped waterlily) was present in many areas of the lake, the predominant floating plant was Little Floating Heart, which is especially prevalent along the west and north shorelines. In denser areas of Floating Heart, small white flowers could be seen, confirming this was not the invasive Yellow Floating Heart. Photos of Little Floating Heart with some Watershield are below.
